HAZARDS PLATE I
SEISMIC & SAFETY ELEMENTS
of the
RESOURCES PLAN & PROGRAM

ventura county planning department
october 1974

MAP OF
THE NORTH HALF OF
VENTURA COUNTY
CALIFORNIA

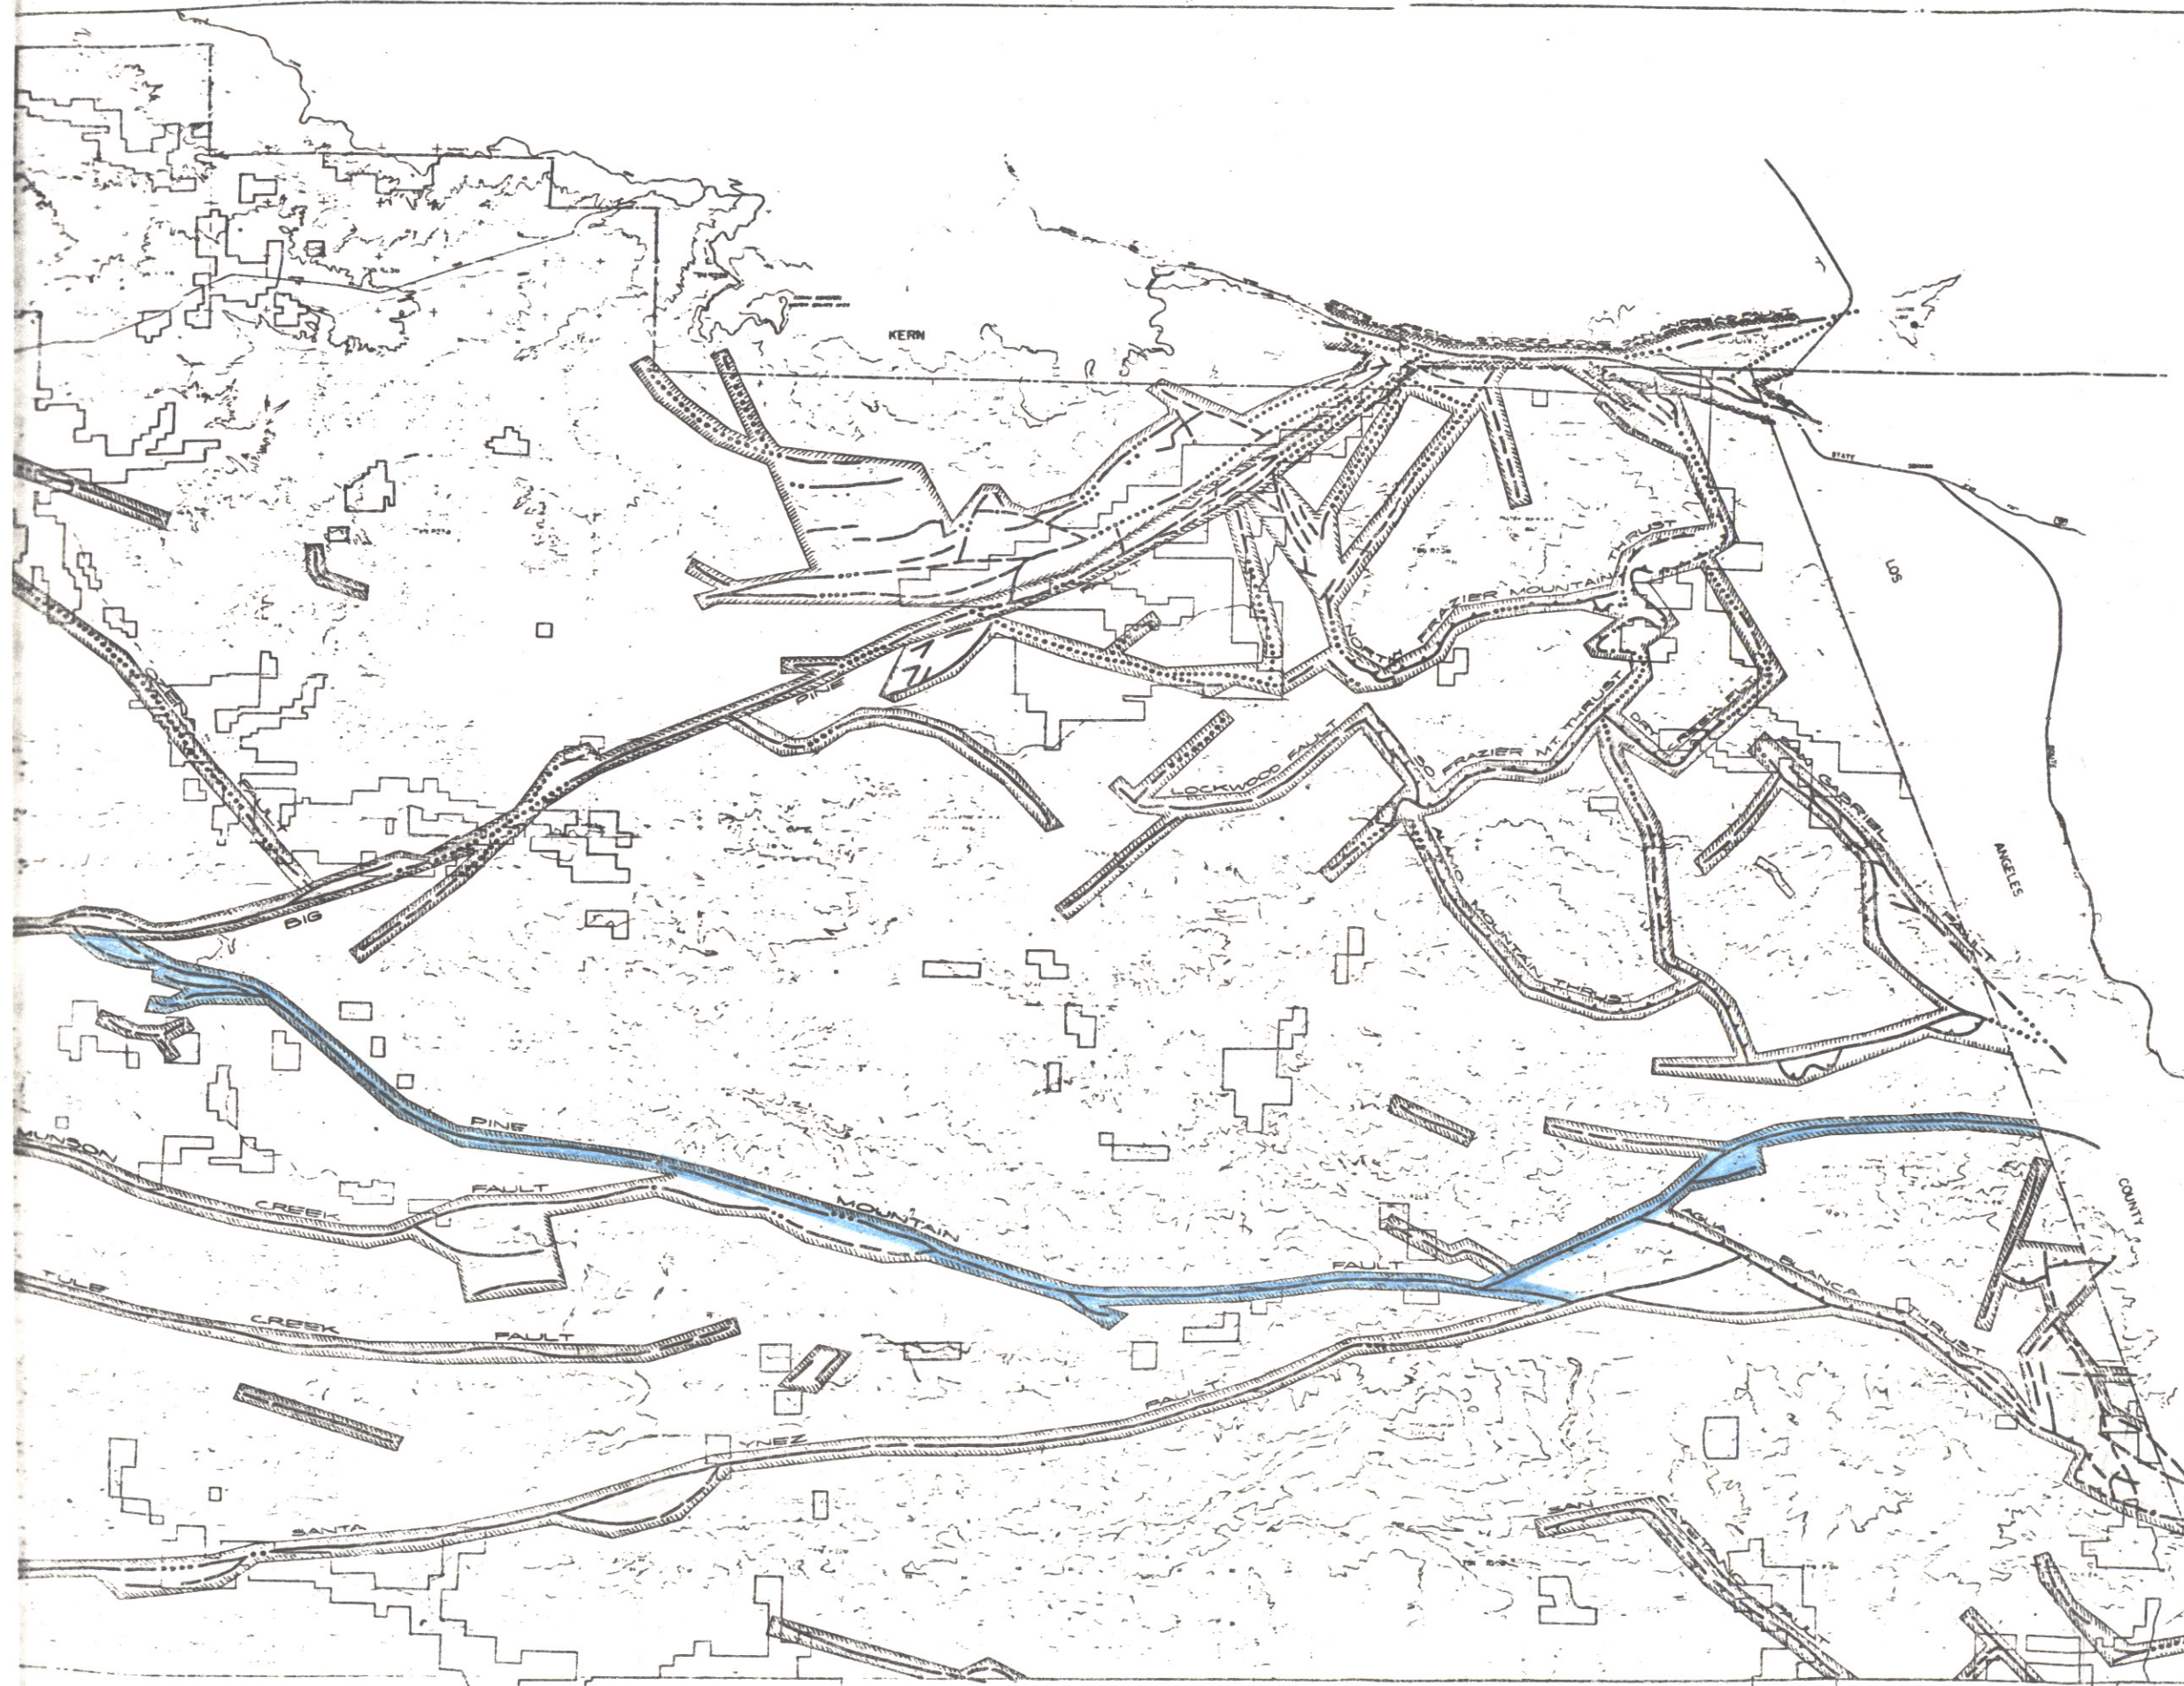
Figure 1 (From Nichols, 1974)

FAULT HAZARD ZONES

- PRIMARY ZONES WHICH CONTAIN FAULTS WHICH HAVE BEEN ACTIVE DURING HISTORIC OR HOLOCENE TIME
 - SECONDARY ZONES WHICH MAY CONTAIN ACTIVE OR POTENTIALLY ACTIVE FAULTS
- NOTE: ZONE BOUNDARIES ARE APPROXIMATELY LOCATED

EARTH FAULTS

- POSITIVELY IDENTIFIED
- RELATIVELY WELL-IDENTIFIED AND/OR RELATIVELY ACCURATELY LOCATED
- CONCEALED
- "TOOTH SYMBOL" DENOTES THRUST FAULT; TEETH ARE DRAWN ON THE UPPER PLATE, DOWN-DIP SIDE OF FAULT

Faults discussed in FER-16
